CWA COMPLIANCE EVALUATION INSPECTION REPORT
U.S. ENVIRONMENTAL PROTECTION AGENCY, REGION 5

Purpose:
Compliance Evaluation Sampling Inspection

Ex. 6 (Personal Privacy) Farms

Date of Inspection:
November 6, 2013

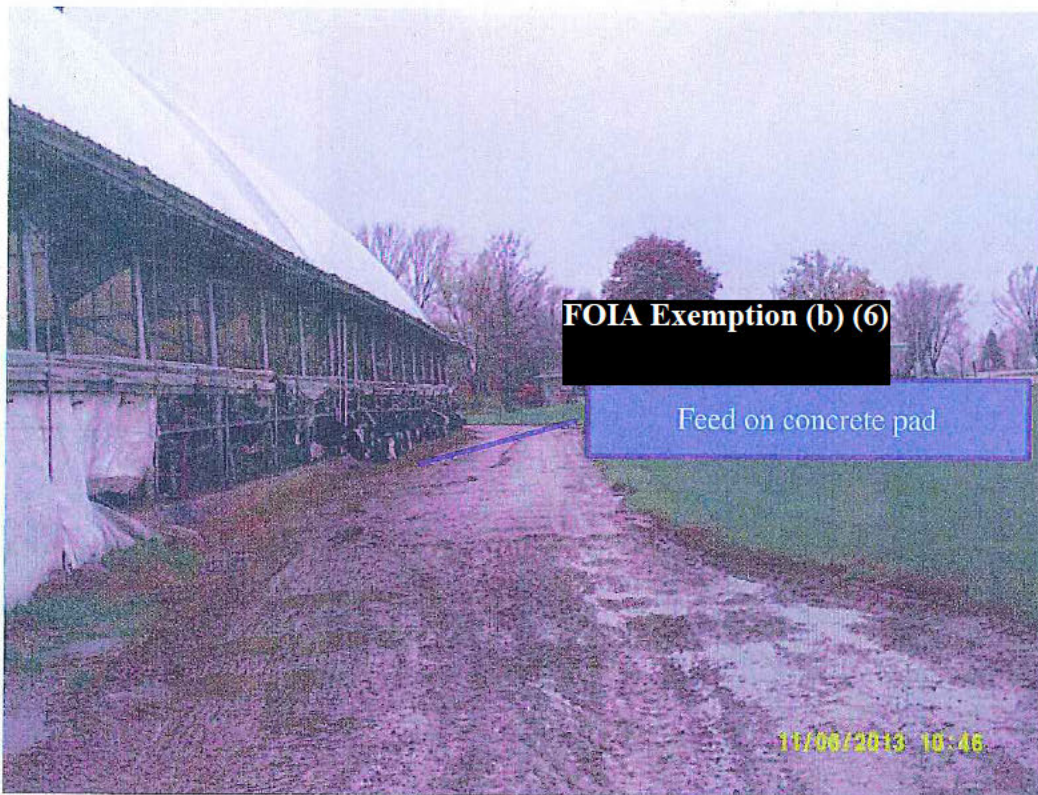
Date/Time: 11/6/2013 10:46 A.M. Location: Southeast corner of Building 2 Facing: North

The inspectors observed a concrete pad along the east side of Building 2 used to feed the animals confined in Building 2. The pad was generally clean on the day of the inspection and the feed was mostly under the overhang of Building 2. EPA observed some precipitation falling on the concrete pad mingling with the feed on the pad resulting in runoff flowing to the unnamed tributary. The flow of potentially contaminated runoff from the concrete pad flowed across the south access road and formed a slight channel as it flowed into the unnamed tributary (pathway 1).

Photo DSCF005: Cows in Building 2 being fed on concrete pad.

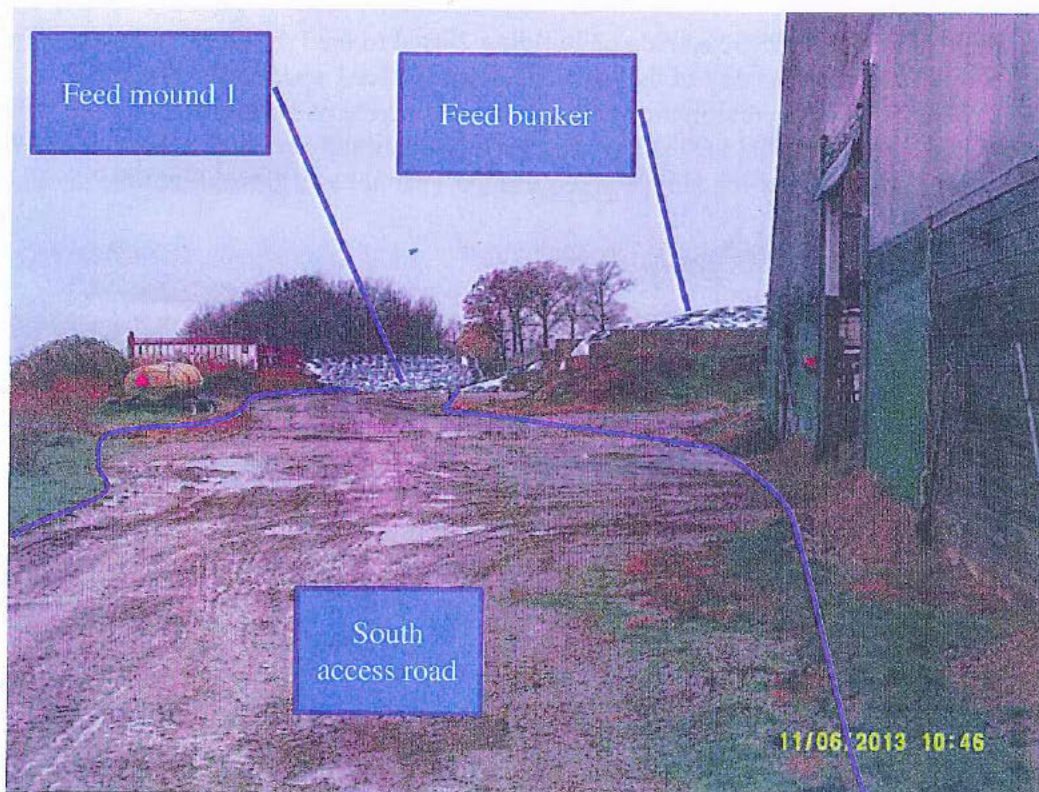
Date/Time: 11/6/2013 10:46 A.M. Location: Southeast corner of Building 2 Facing: West

Photo DSCF0007: South side of Barn 2. South access road with Feed Bunker and Feed Mound 1 visible.

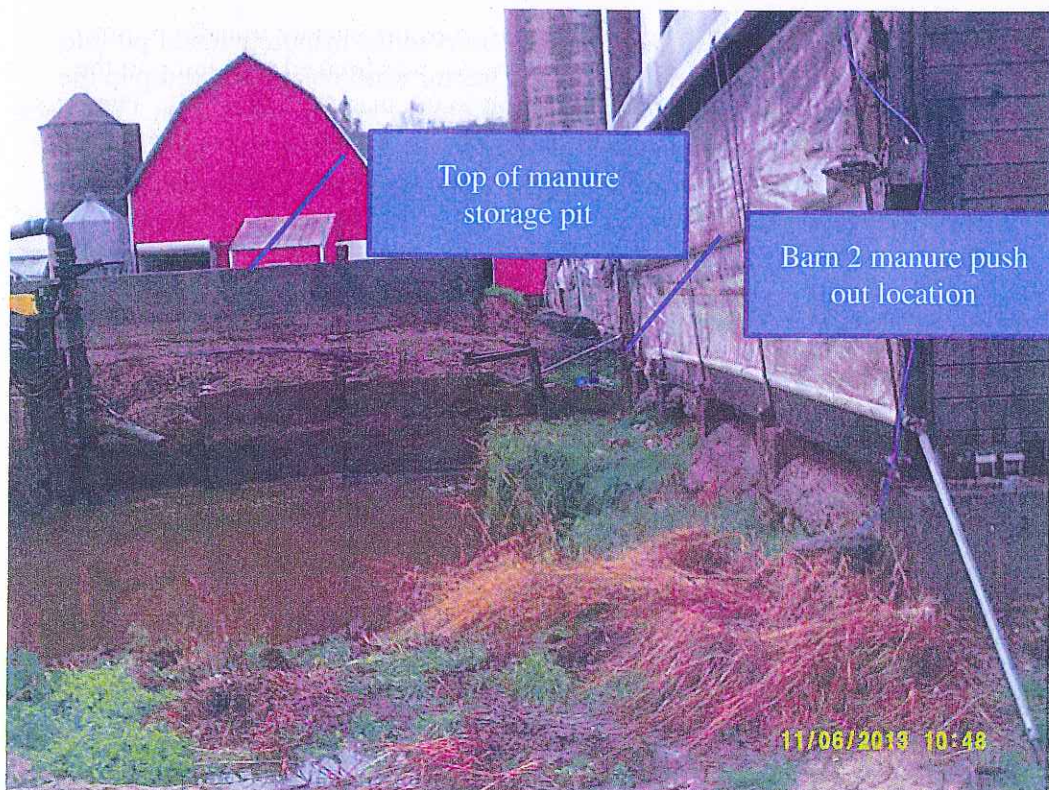
The inspection proceeded west on the south side of Building 2. EPA observed the manure transfer pit into which manure is pushed from Building 2. At the time of inspection, a tractor was hooked to a pump in the transfer pit. This pump, when active, pumps manure from the transfer pit to the manure storage pit. The back side of the manure storage pit was visible immediately north of the transfer pit. Precipitation runoff from the transfer pit pump area where the tractor was parked and surrounding access road was noted flowing south across the south access road toward the unnamed tributary.

Photo: DSCF0010 – Transfer Pit manure pushed in from Building 2 into the transfer pit
 Date/Time: 11/6/2013 10:48 A.M. Location: Southwest corner of Building 2 Facing: North

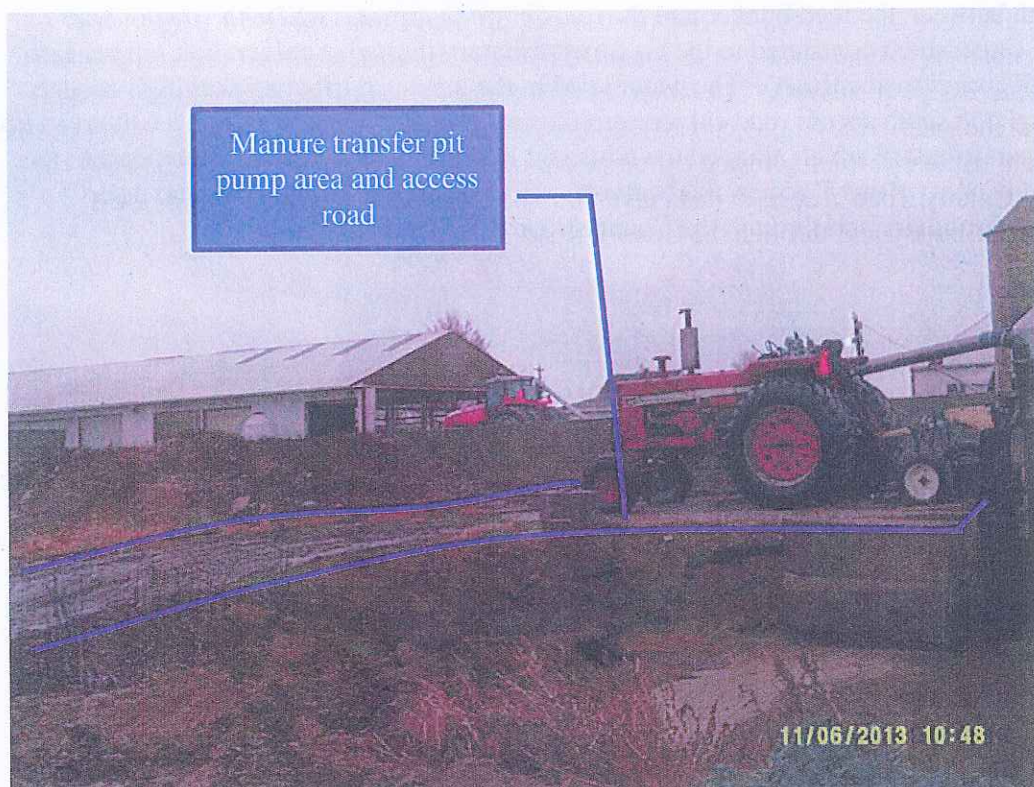
Photo: DSCF0011- Manure transfer pit on the West Side of Building 2
 Date/Time: 11/6/2013 10:48 A.M. Location: Southwest corner of Building 2 Facing: Northwest

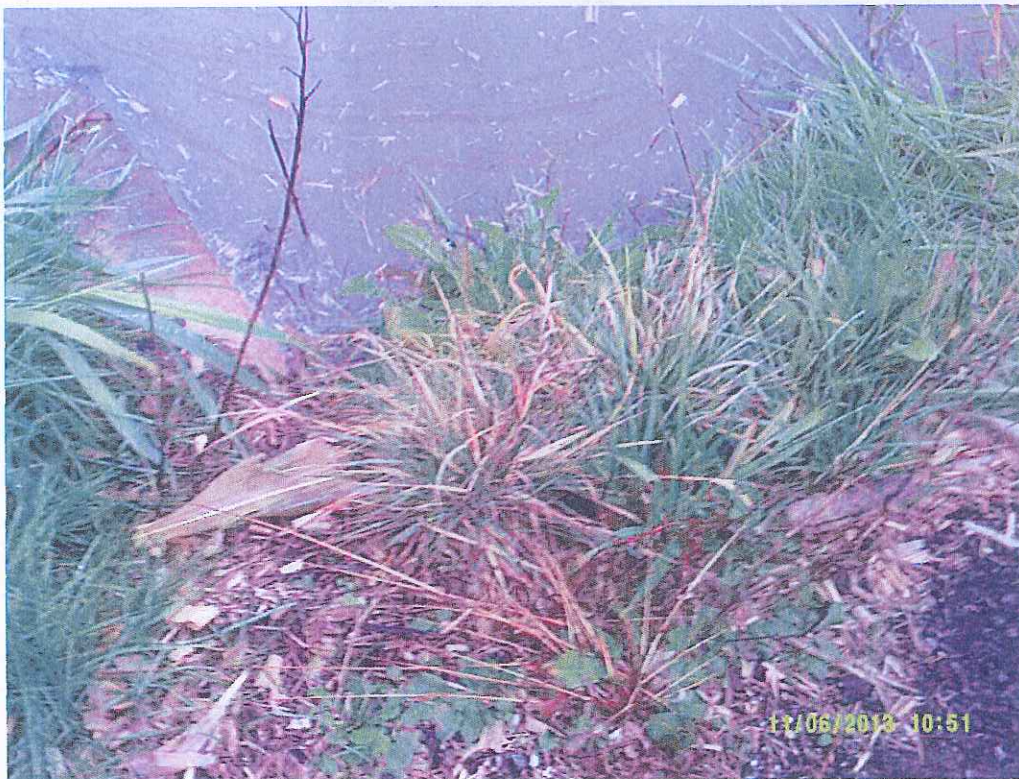
Date/Time: 11/6/2013 10:51 A.M. Location: North side of south access road culvert. Facing: Down

The inspectors noted a ditch between the feed bunker and the transfer pit pump area where the tractor was parked (center ditch). The center ditch connected to the unnamed tributary through a culvert that ran beneath the south access road (south access road culvert). The water level in the unnamed tributary was high enough that it had backed up through the south access road culvert into the center ditch. There was also a culvert in line with the unnamed intermittent tributary which allowed the unnamed intermittent tributary to flow beneath the County Road T access road (County Road T access road culvert). The inspectors checked for and noted flowing water in the unnamed tributary and through the County Road T access road culvert.

Photo: DSCF0014: North end of south access road culvert connecting ditch located between manure transfer pit pump area and the feed bunker to the unnamed intermittent tributary.

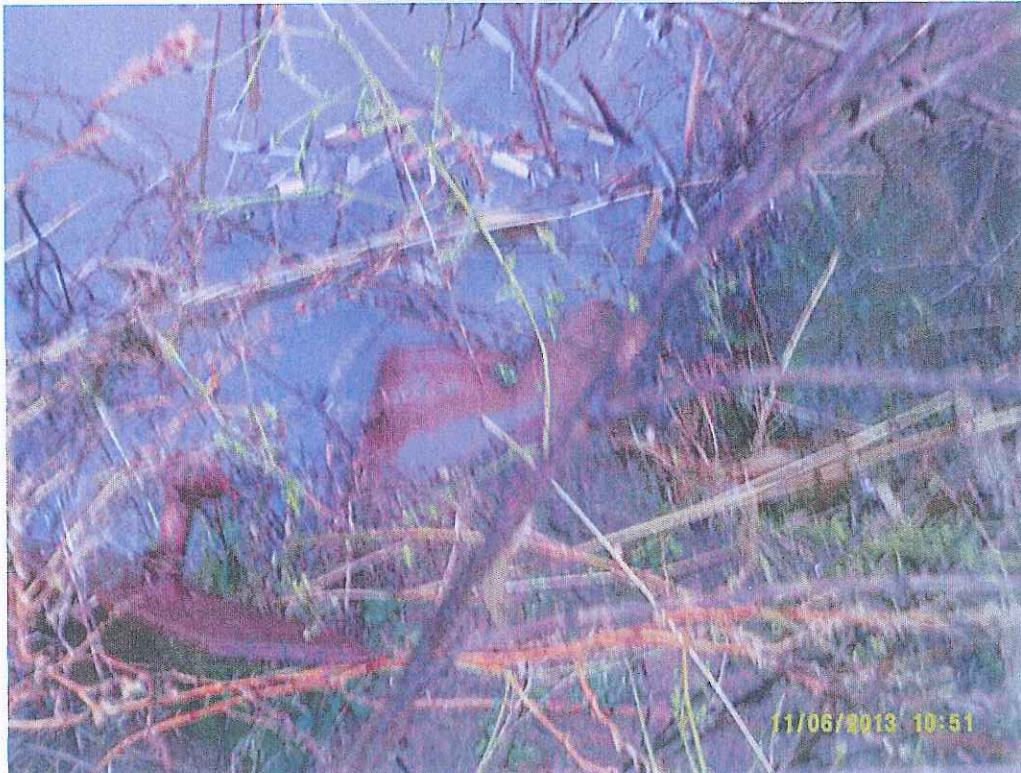
Date/Time: 11/6/2013 10:51 A.M. Location: South side of south access road culvert. Facing: Down

Photo: DSCF0015: South end of south access road culvert connecting ditch located between manure transfer pit pump area and the feed bunker to the unnamed intermittent tributary.

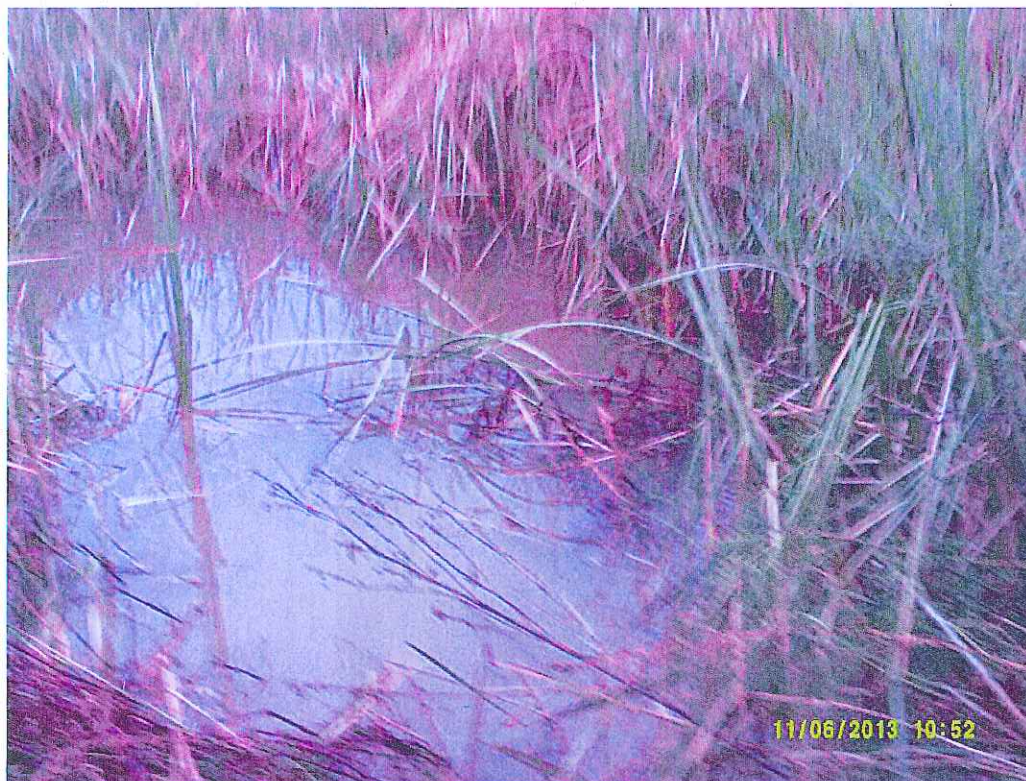
Date/Time: 11/6/2013 10:52 A.M. Location: South of south access road between Building 2 and feed bunker
Facing: South

Photo DCSF 0016: Water in unnamed intermittent tributary.

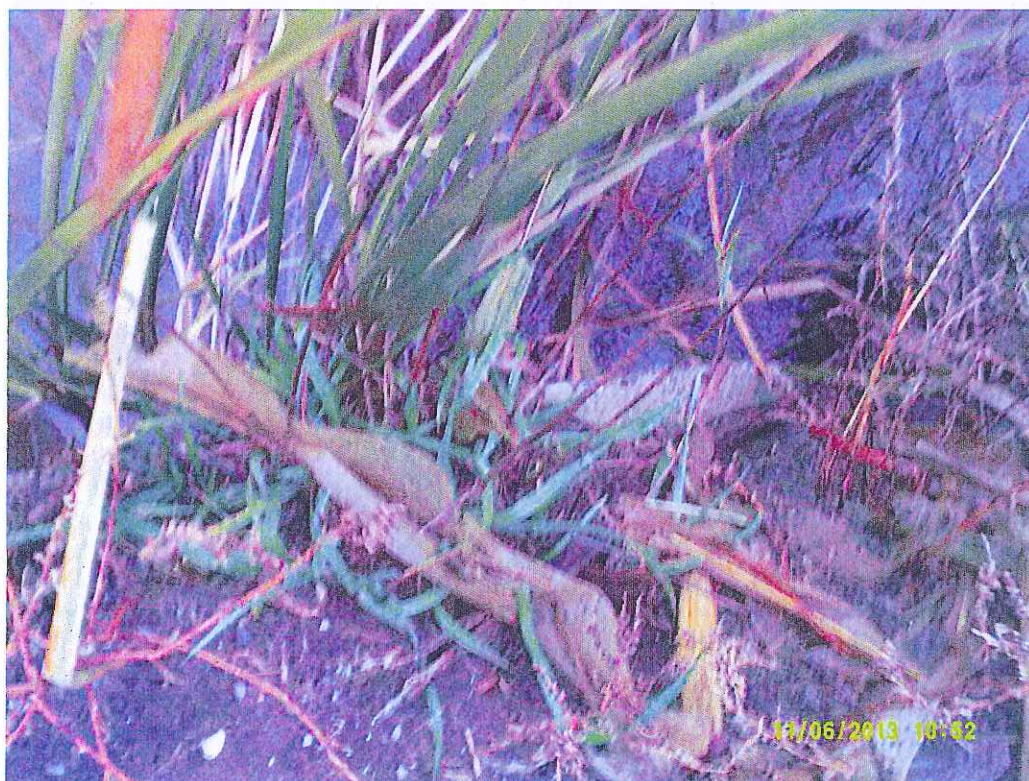
Date/Time: 11/6/2013 10:52 A.M. Location: East side of County Road T access road culvert. Facing: Down

Photo DSCF0017: East side (upstream) of County Road T access road culvert.

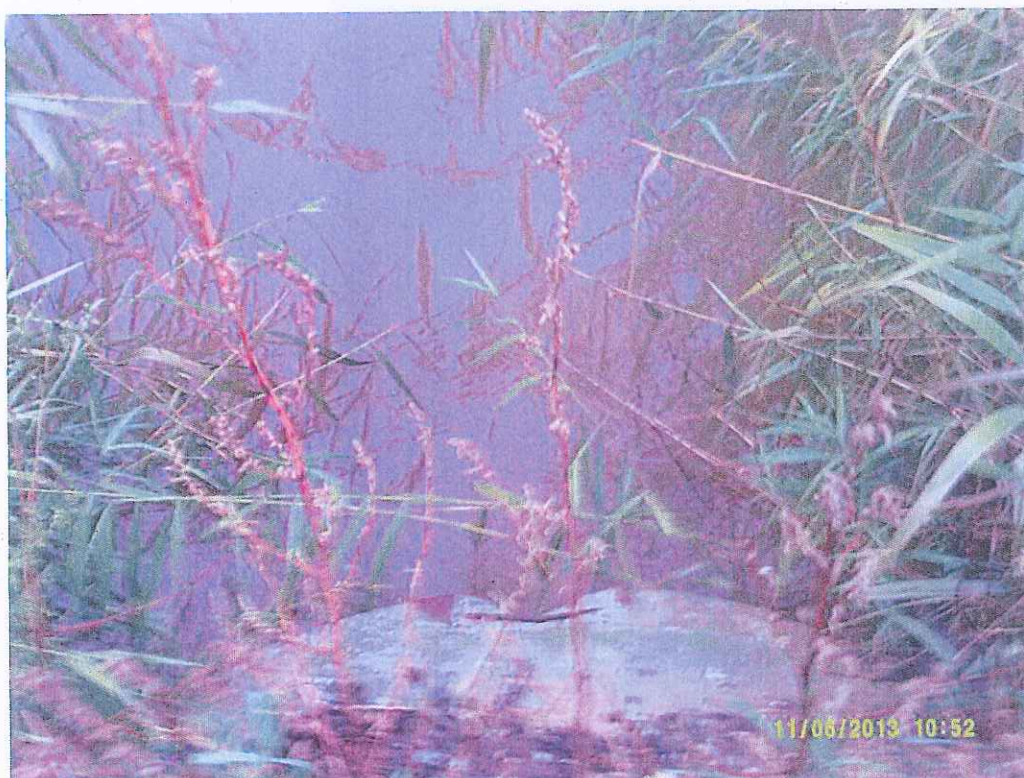
Date/Time: 11/6/2013 10:52 A.M. Location: West side of County Road T access road culvert. Facing: Down

Photo DSCF0018: West side (downstream) of County Road T access road culvert.

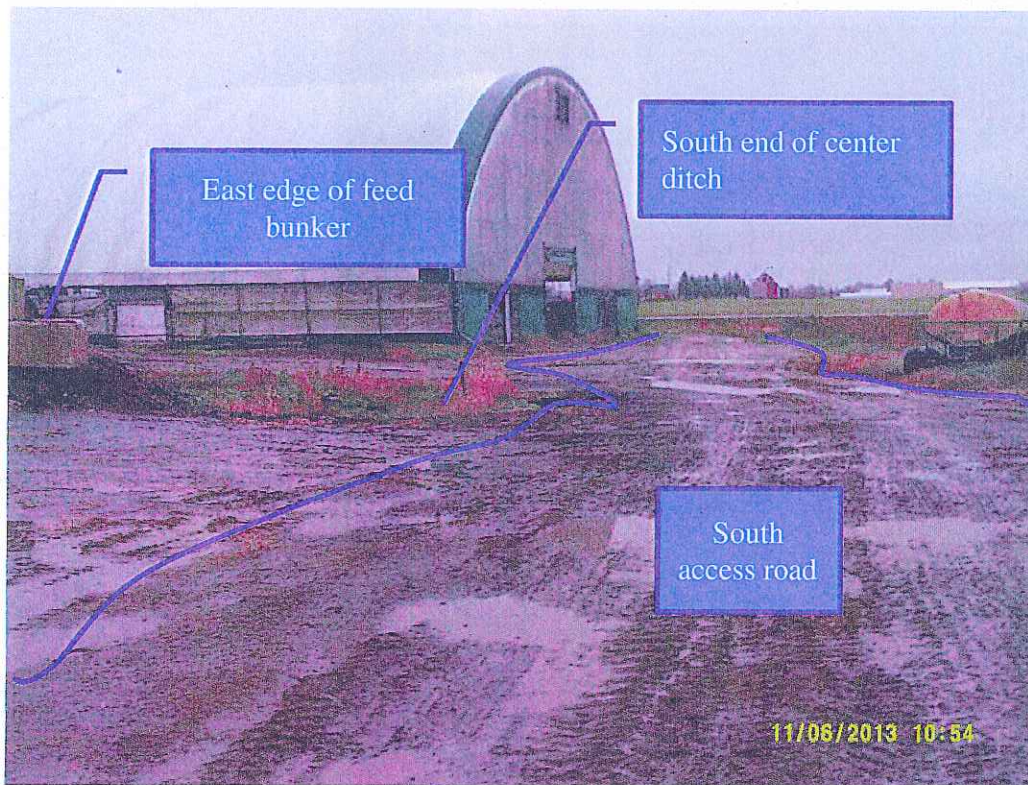
Photo 0019: South end of center ditch and edge of feed bunker on the south access road.
 Date/Time: 11/6/2013 10:54 A.M. Location: South access road west of center ditch Facing: East

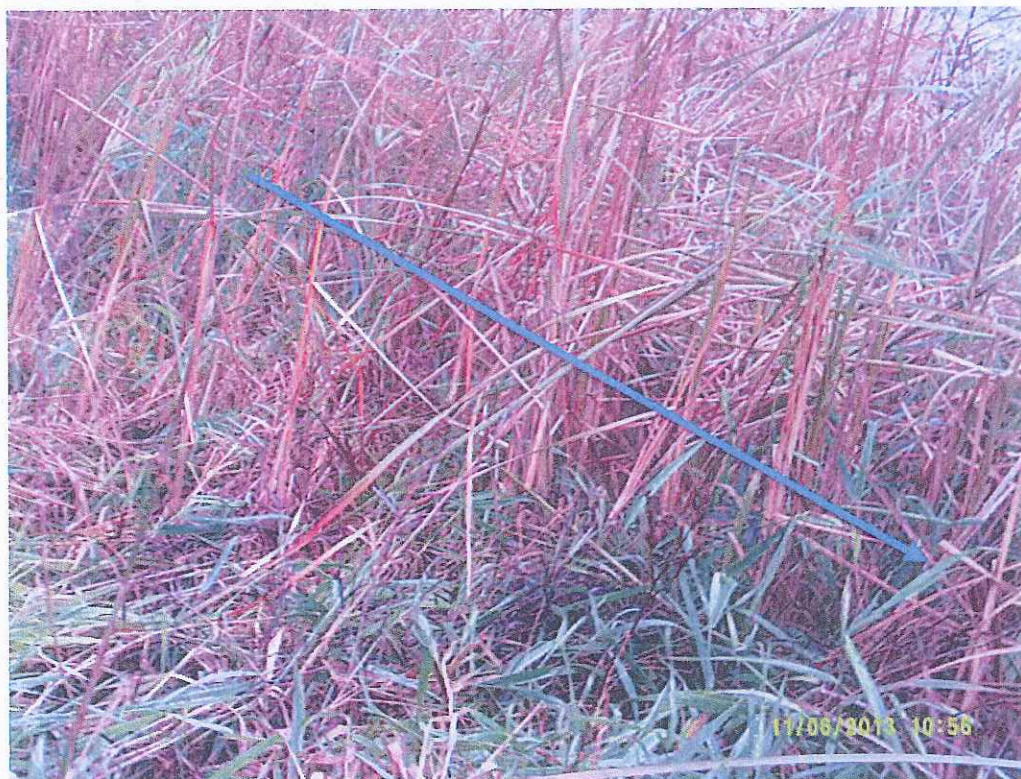
The Inspectors continued west along the south side of the facility. The inspectors noted the flow of water in the unnamed intermittent tributary. There was what appeared to be a black residue on the vegetation and ground along the edge of the unnamed intermittent tributary. The slope of the ground and flow of surface water around the facility is towards the unnamed intermittent tributary

DSCF0021: Water in unnamed intermittent tributary. Direction of flow indicated by blue arrow.
 Date/Time: 11/6/2013 10:56 A.M. Location: West of center ditch and south of feed bunker.
 Facing: Southeast

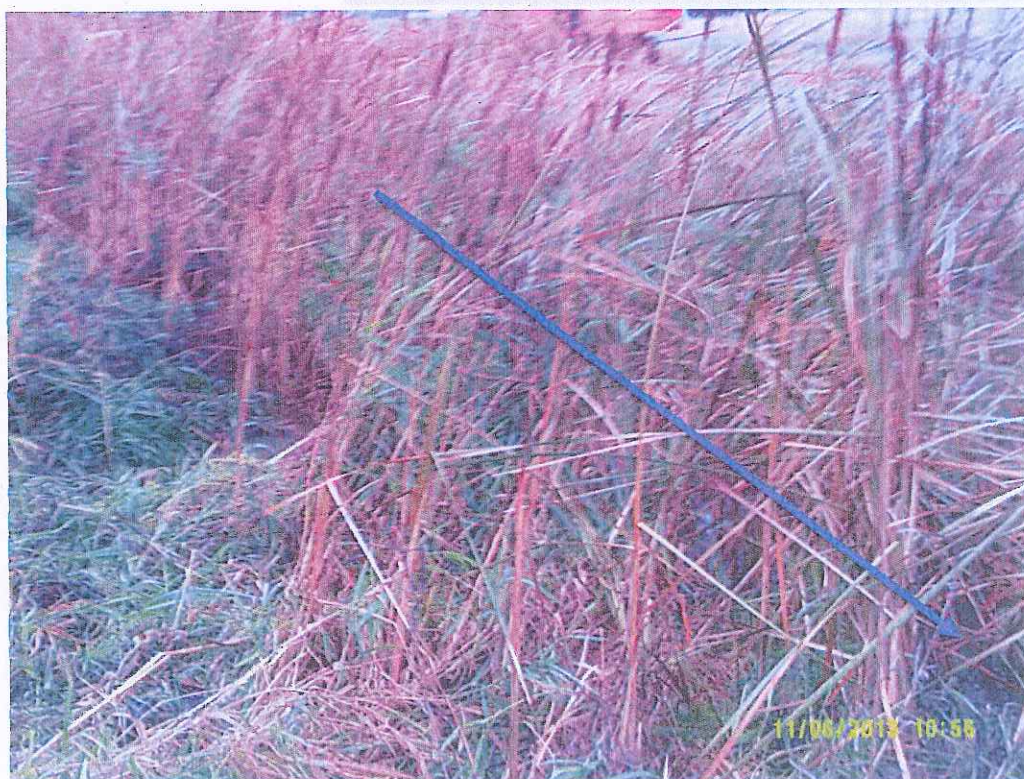
Photo DSCF0022: Water in unnamed intermittent tributary. Direction of flow indicated by blue arrow.
 Date/Time: 11/6/2013 10:56 A.M. Location: West of center ditch and south of feed bunker
 Facing: Southeast

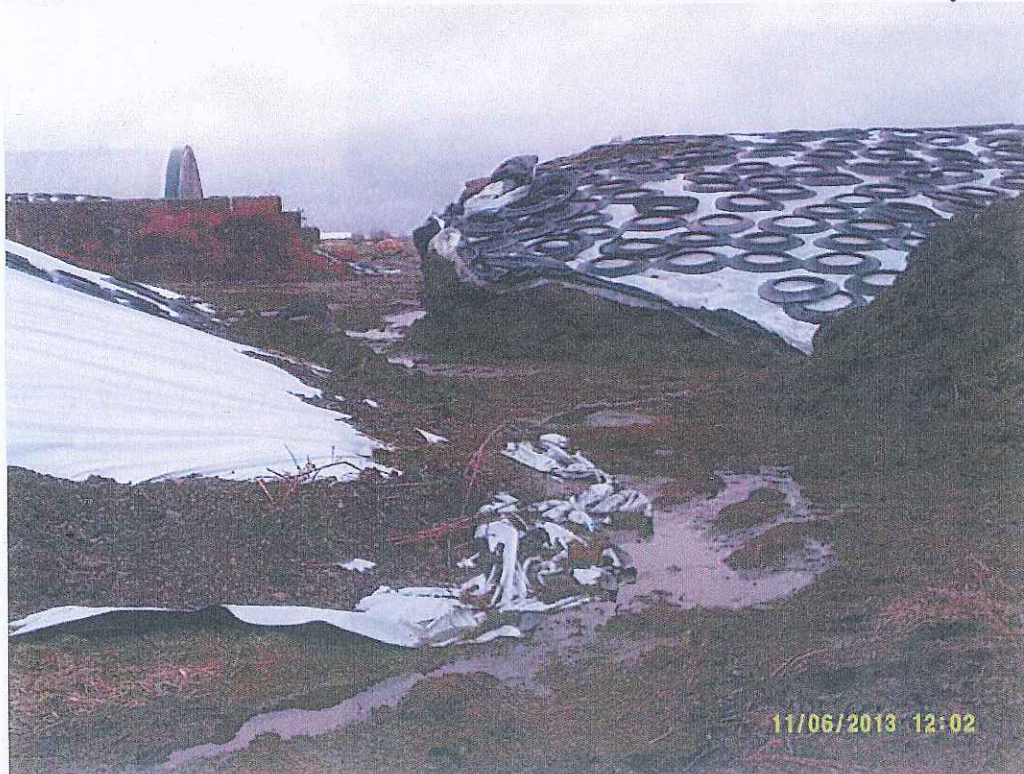
Date/Time: 11/6/2013 12:02 P.M. Location: West side of facility between covered feed mounds 1 and 2 Facing: East

Photo DSCF0068: Flow of leachate and surface runoff from between covered feed mounds 1 and 2 west to unnamed intermittent tributary

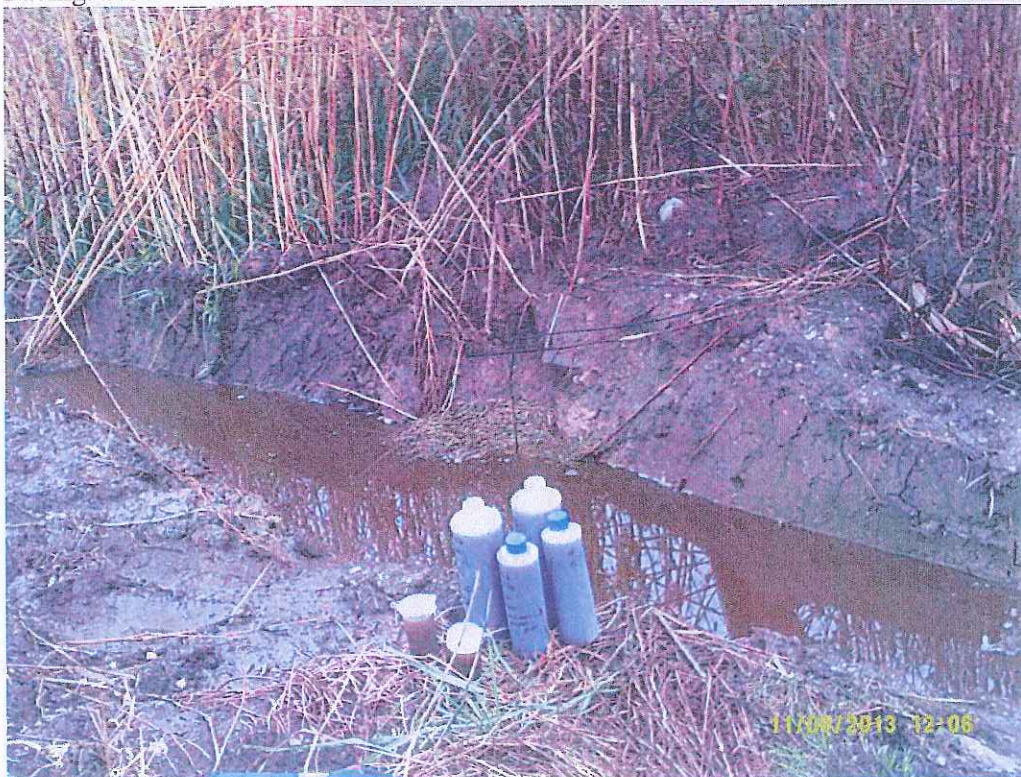
PhotoDSCF0070: Pathway 2 and sample S02.
 Date/Time: 11/6/2013 12:06 P.M. Location: West side of facility between covered feed mounds 1 and 2.
 Facing: Northwest

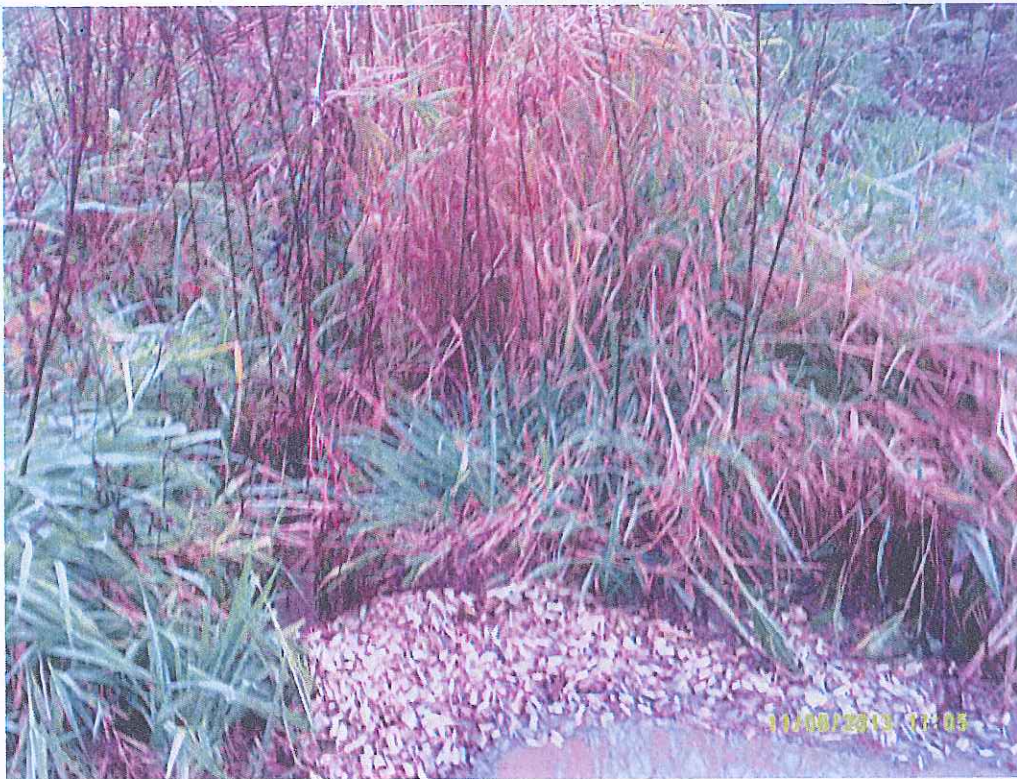
The second channel was located west between covered feed mounds 2 and 3 (pathway 3). Pathway 3 was also observed to be transporting leachate, surface runoff, and feed debris from between covered feed mounds 2 and 3 and surrounding areas to the unnamed intermittent tributary. Pathway 3 is sampling location for sample S03.

Photo DSCF0031: Pathway 3 conveying runoff, leachate, and feed debris to unnamed intermittent tributary.
Date/Time: 11/6/2013 11:05 A.M. Location: West side of covered feed mound 2 and 3. Facing: Northwest

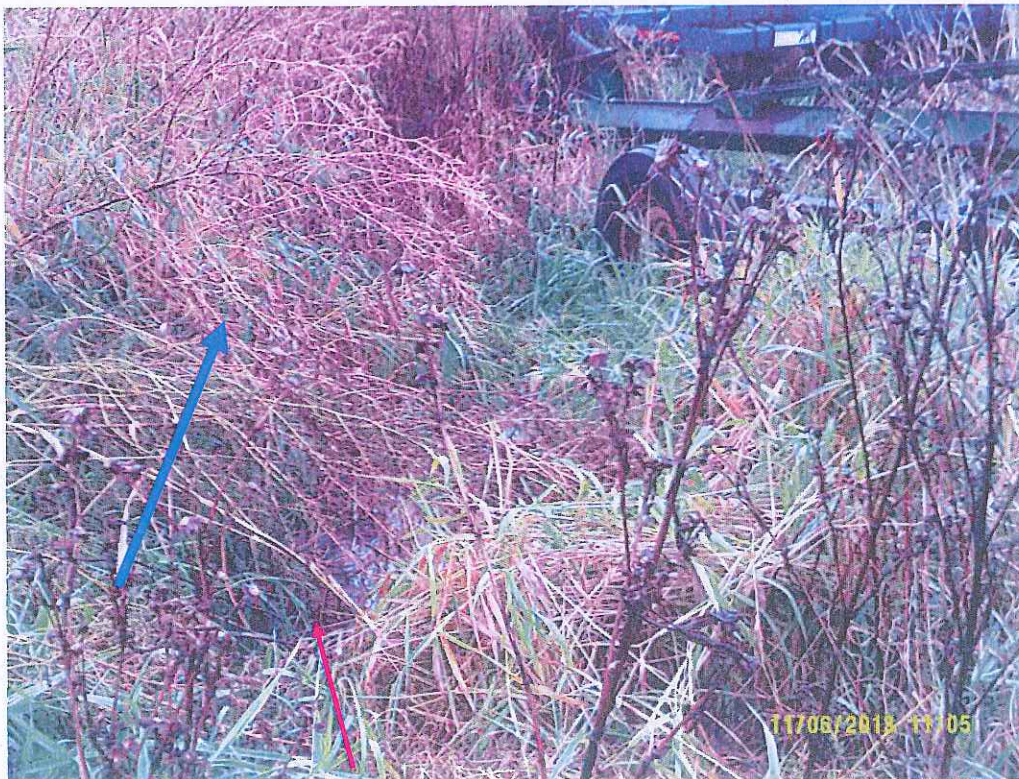
Photo DSCF0030: Pathway 3 conveying runoff, leachate, and feed debris to unnamed intermittent tributary.
Red arrow indicating pathway 2 and blue arrow indicating flow direction of unnamed intermittent tributary.
Date/Time: 11/6/2013 11:05 A.M. Location: West side of covered feed mound 2 and 3. Facing: Northwest

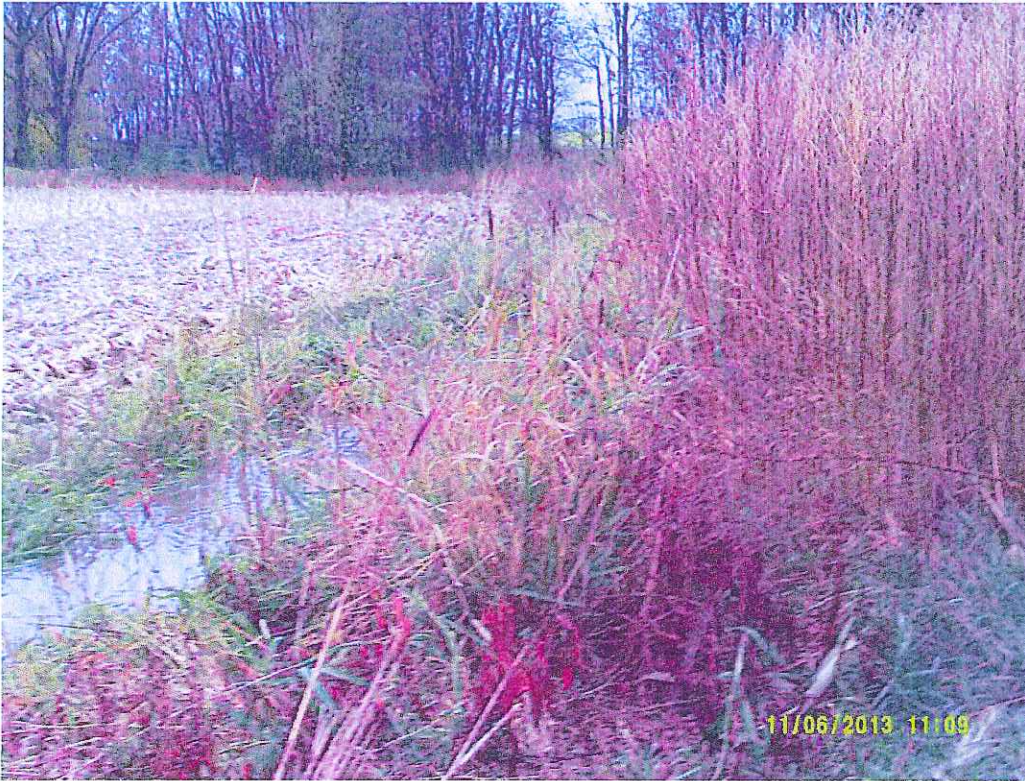
Date/Time: 11/6/2013 11:09 A.M. Location: West side of facility. Facing: Northwest

Photo DSCF0036: Unnamed intermittent tributary flowing to the northwest.

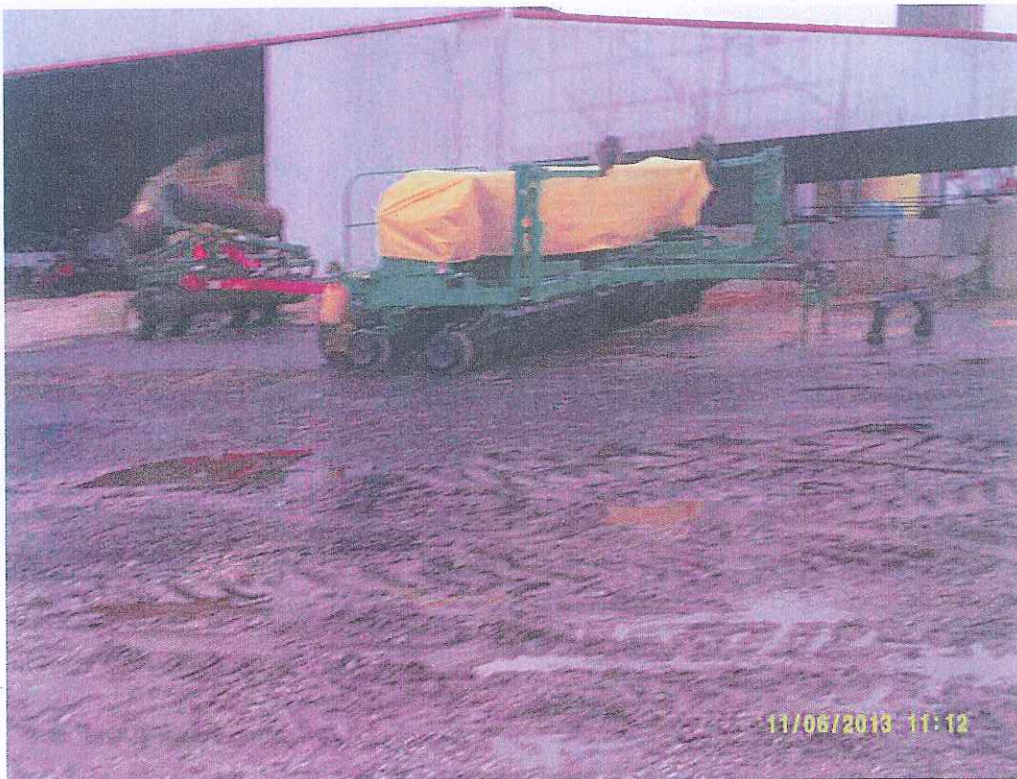
Photo DSCF0040: Building 3 used for machine storage and heifers.
Date/Time: 11/6/2013 11:11 A.M. Location: West of Building 3 Facing: East

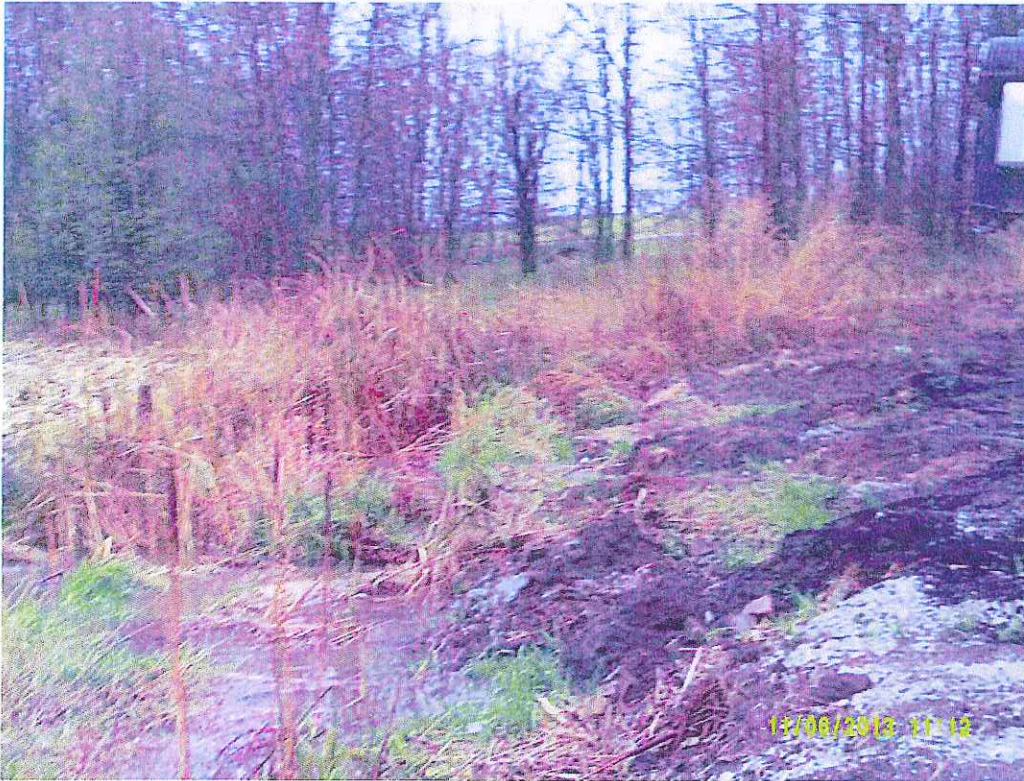
Photo DSCF0042: Unnamed intermittent tributary flowing to the North.
 Date/Time: 11/6/2013 11:12 A.M. Location: West of parked trucks and machinery. Facing: North

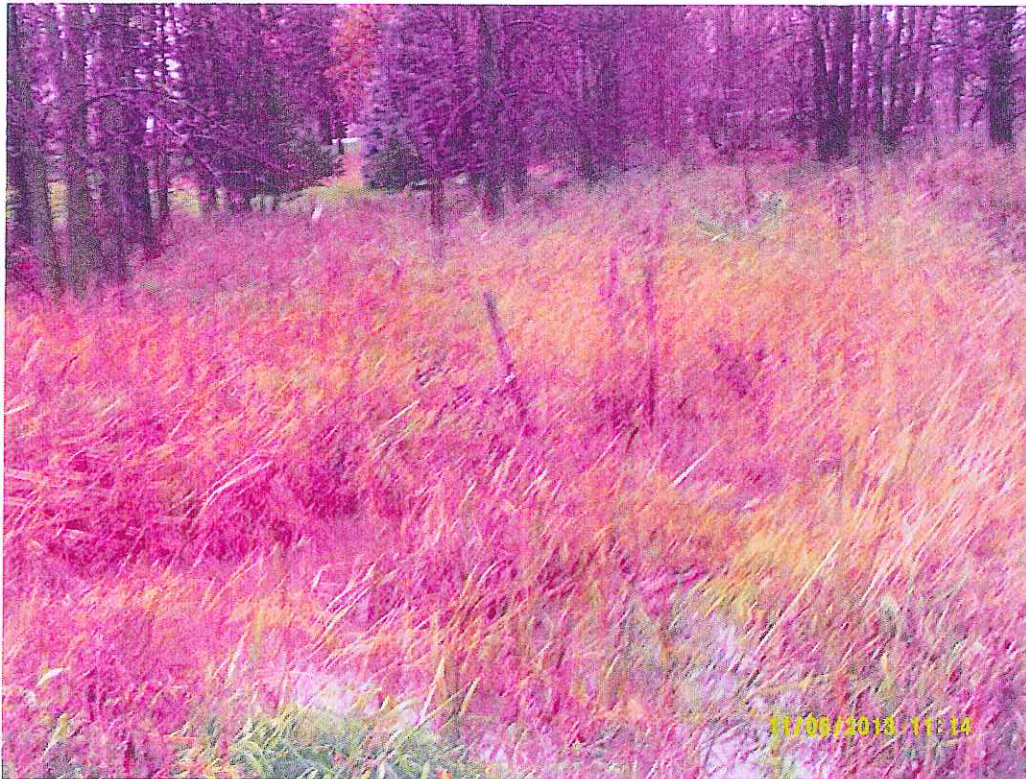
Photo DSCF0043: Water in the unnamed intermittent tributary.
 Date/Time: 11/6/2013 11:14 A.M. Location: Northwest corner of facility. Facing: Northwest

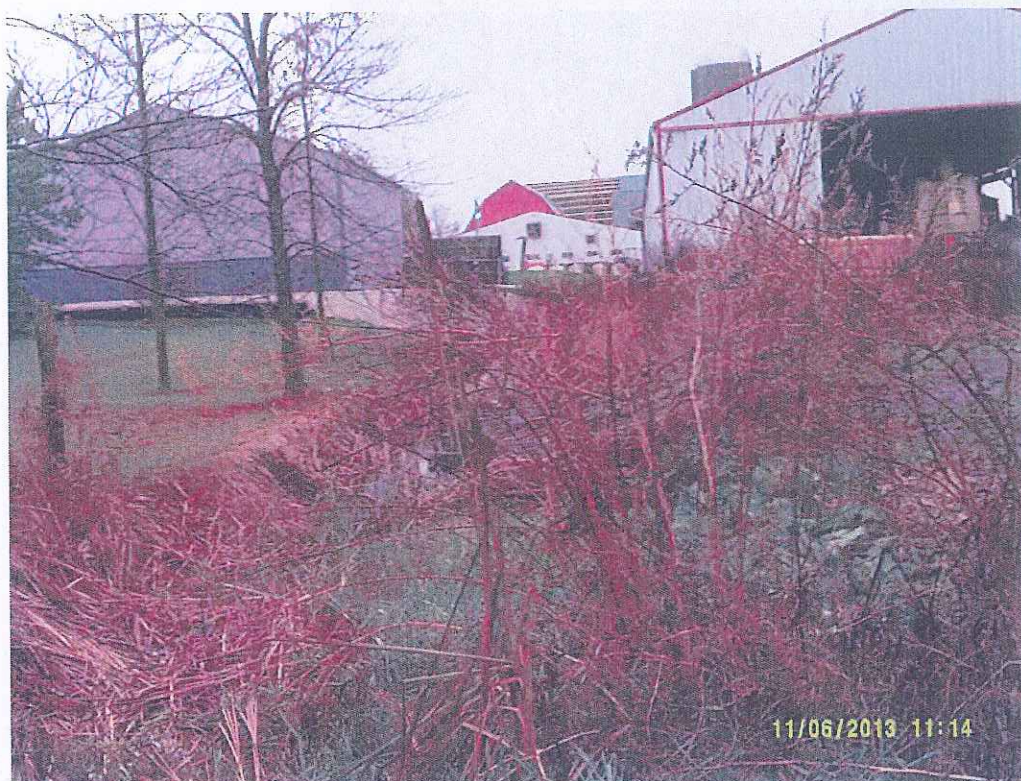
Date/Time: 11/6/2013 11:14 A.M. Location: West of Building 3. Facing: East

The inspectors walked the ditch on the facility's northern side and noted multiple pipes and a culvert that exited into the ditch (north ditch). The operator stated that he did not know the source of the pipes and that he believed they came from the adjacent land owners property.

Photo DSCF0044: North ditch.

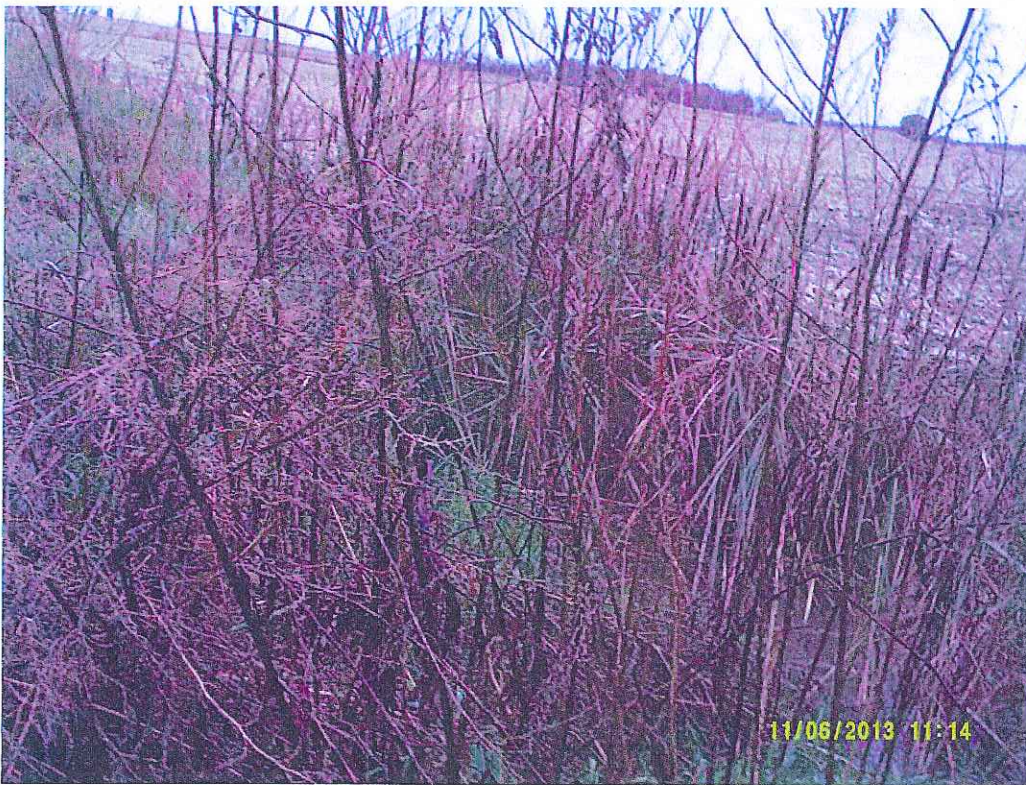
Photo DSCF0045: Flowing water in unnamed intermittent tributary.
 Date/Time: 11/6/2013 11:14 A.M. Location: Northwest corner of facility. Facing: West

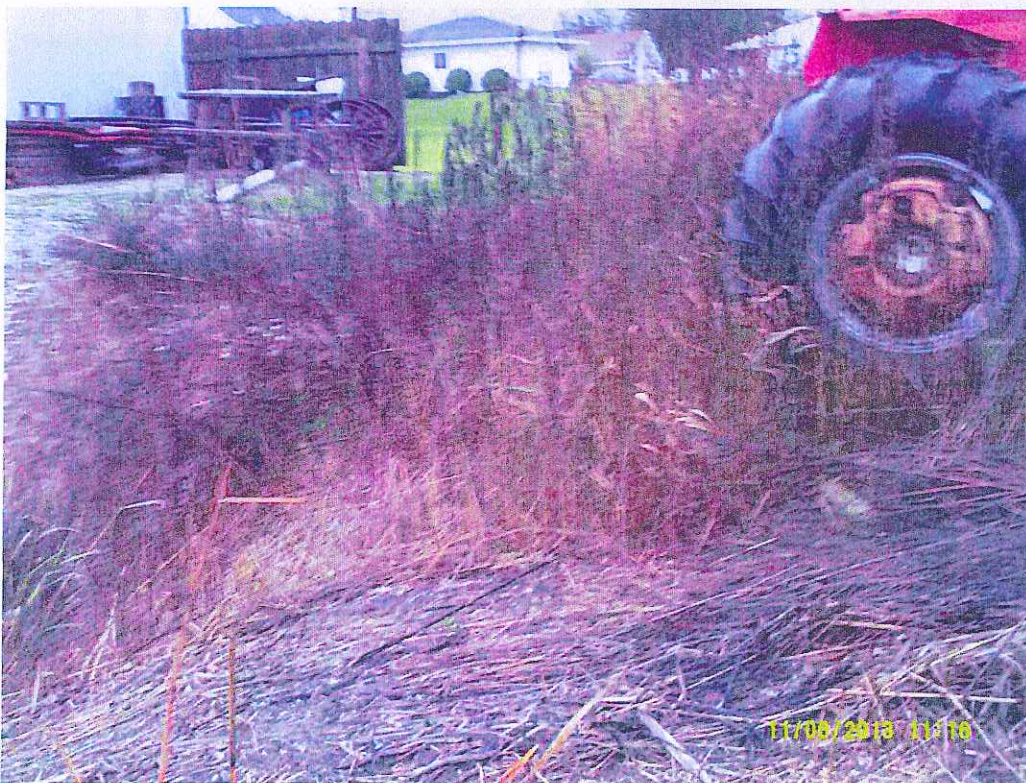
Photo DSCF0046: North ditch on northwest side of the facility.
 Date/Time: 11/6/2013 11:16 A.M. Location: northwest of Building 3. Facing: Northeast

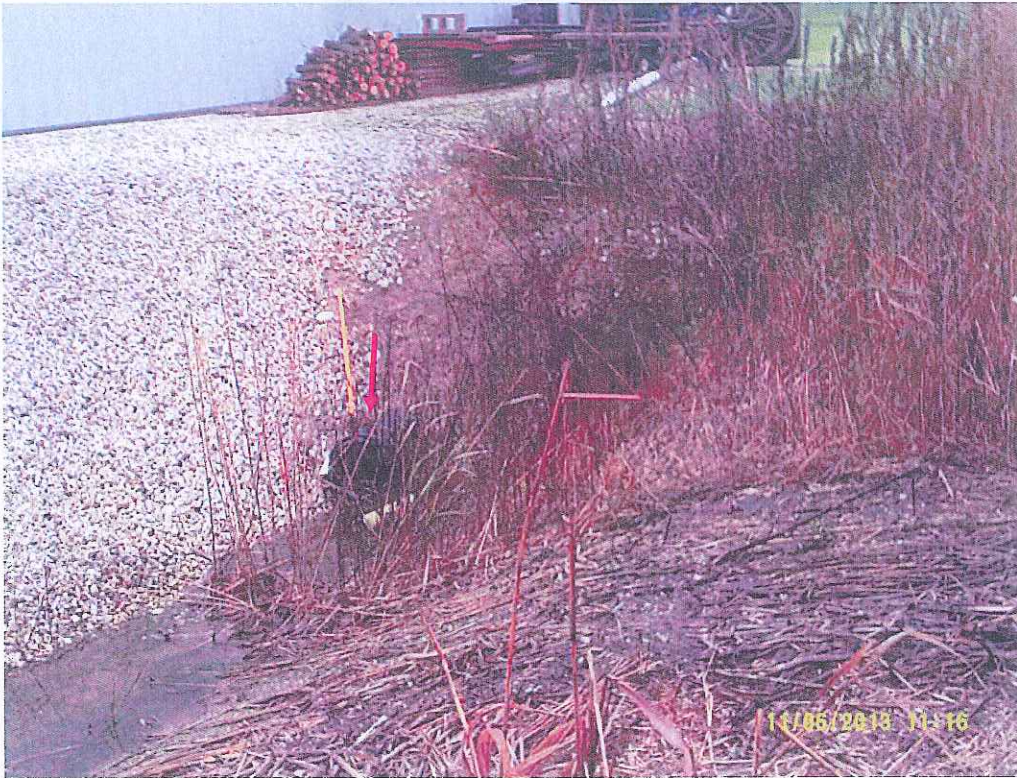
Date/Time: 11/6/2013 11:16 A.M. Location: Northwest Building 3. Facing: Northeast

Photo DSCF0047: Culvert within the north ditch.

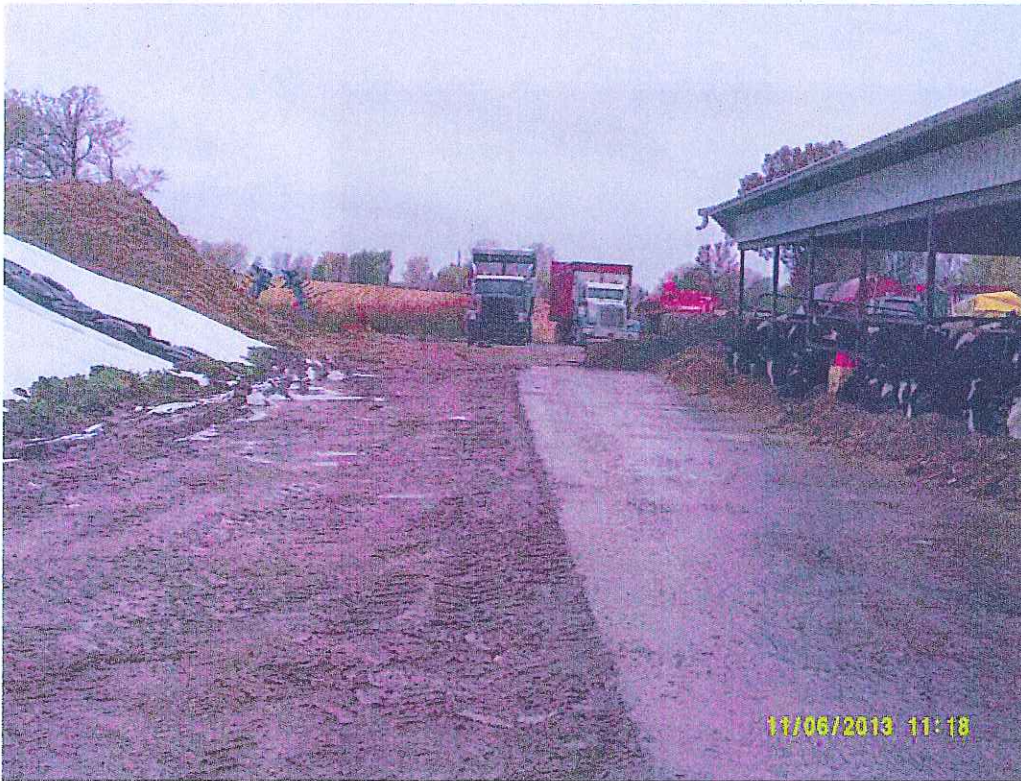
Date/Time: 11/6/2013 11:18 A.M. Location: North access road south of Building 3. Facing: West

The inspectors walked east on the north access road between covered feed mound 3 and Building 3. The inspectors turned south and walked between the covered feed mounds and the feed bunker. The ground surface of the facility appeared to be a patchwork of concrete, blacktop, and gravel. A stack of baled compost material used for bedding was seen north of covered feed mound 3. The inspectors walked south between the feed bunker and covered mounds and noted the surface runoff flowing west between the covered feed mounds. This runoff was seen to be flowing through loose feed, leachate, and feed debris and flowing to pathways 2 and 3 to the unnamed intermittent tributary.

Photo DSCF0048: South of Building 3.

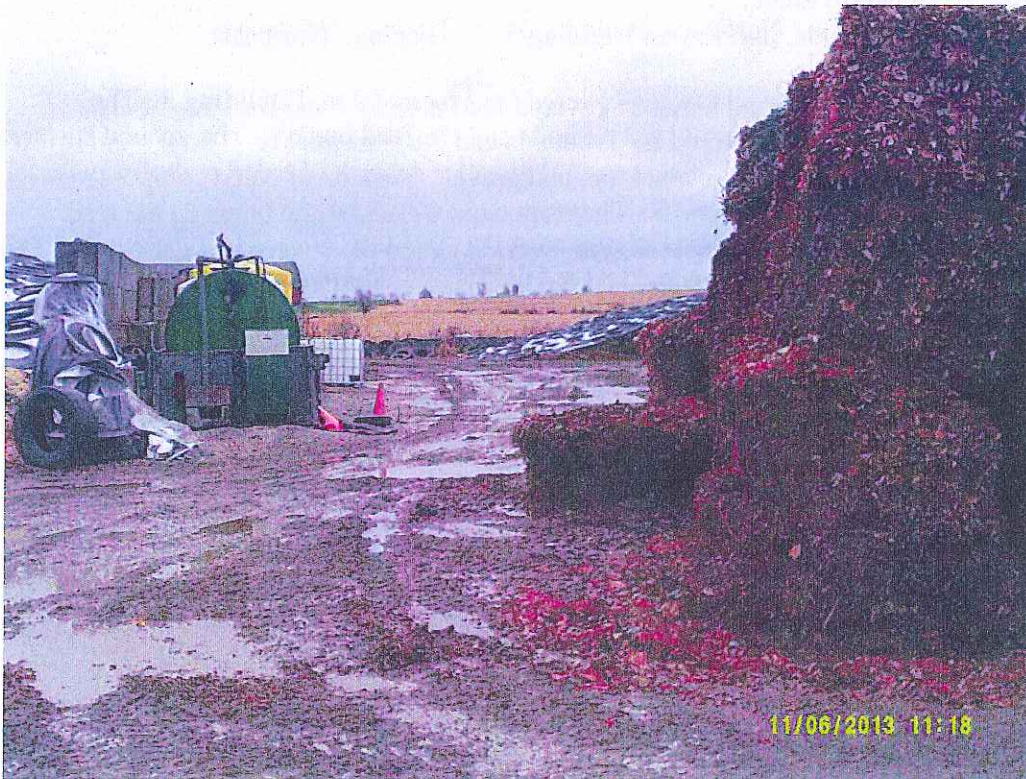
Date/Time: 11/6/2013 11:18 A.M. Location: Northwest of feed bunker.

Photo DSCF0049: Compost material and feed bunker.
